Manhole Inspection Summary

Manhole # S31GG_035MH

Insp Date: **1/23/07 12:18 PM**

Location Address: **HOWARD ST**

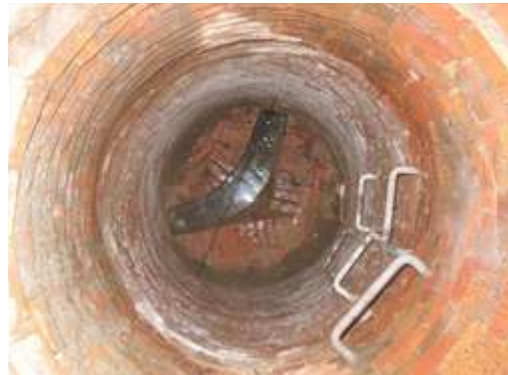
Top View

Corroded steps. Evidence of surcharge - Bench debris. Channel debris.

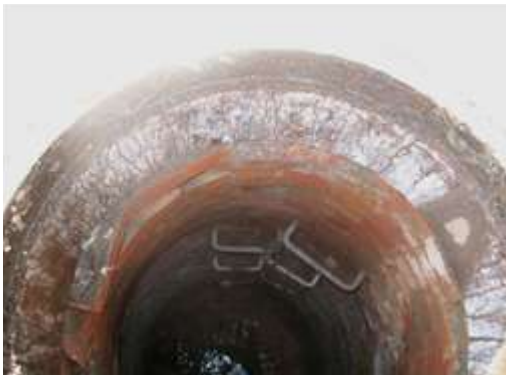
Defect

Adjustment deterioration, loose brick and infiltration. Corbel and Barrel infiltration.

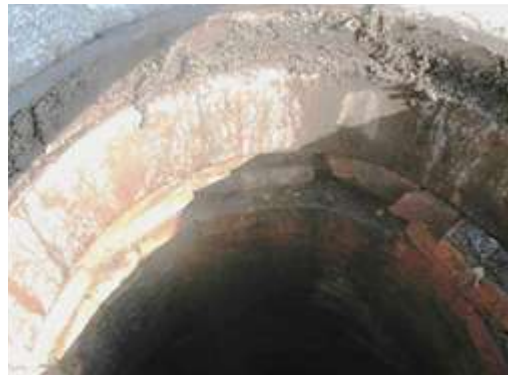
Defect

Adjustment deterioration, loose brick and infiltration.

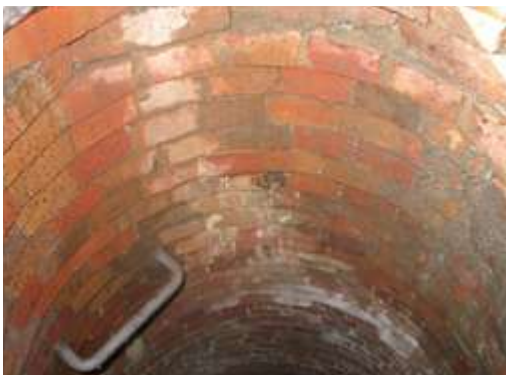
Defect

Adjustment deterioration and infiltration. Corbel and Barrel infiltration.

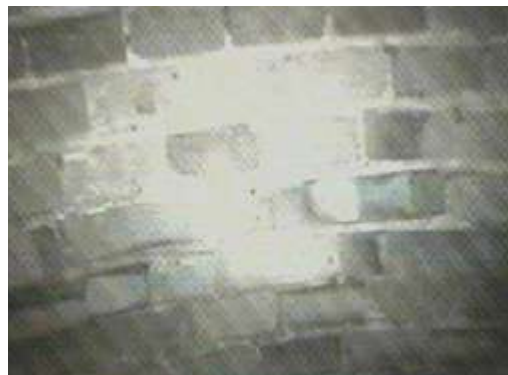
Defect

Barrel deterioration and infiltration.

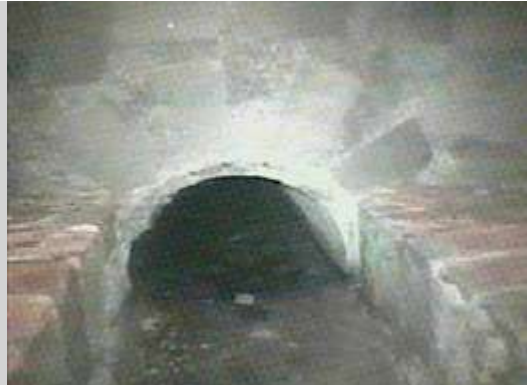
8 in. Circular Gravity Sewer Pipe Out @ 12 O'Clock

Deposits: ☐ None ☒ **Mud** ☐ Sludge ☒ **Debris** ☐ Grease

Silt Depth: **2** (in.) Deposits Extent: **Light**

Infiltration: **Evidence** Pipe Seal Cond: **Unknown**

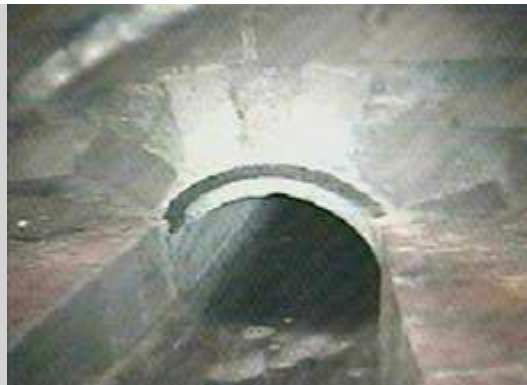
8 in. Circular Gravity Sewer Pipe In @ 8 O'Clock

THIS LINE IS CONNECTED TO MH 007,
BUT MH 007 IS A STORM SEWER, BUT
THERES FLOW COMING FROM THAT
DIRECTION...
